Alta Vista Inspection Services

CONFIDENTIAL INSPECTION REPORT

12345 West Cactus Way, Phoenix, AZ. 85254

12/07/2004 1:00 pm

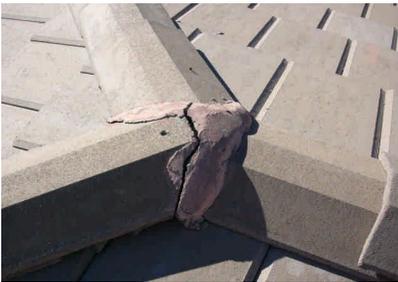
Issue: Cracked or broken roof tiles were noted

Location: About three broken tiles were noted at the NE corner of the roof

Explanation: Cracked and broken tiles may result in premature deterioration of the roofing paper due to UV degradation. Water may also leak into the roof at the cracked/broken tiles. (Repair Recommended)

Issue: Gaps noted in the mortar on the roof

Explanation: Mortar should be installed at certain locations on the tile roof to make these areas water-resistant. If there are gaps in the mortar, the roof may leak in this area. (Repair Recommended)

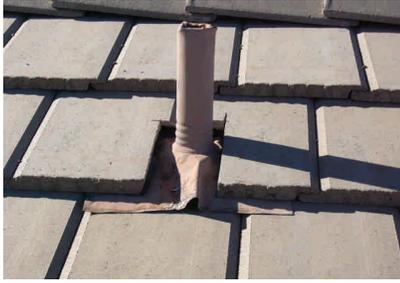
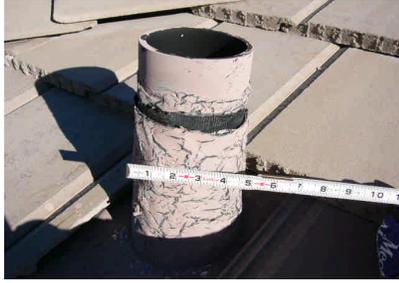
Issue: A portion of the roof drains towards wall

Explanation: Roofs that slope towards a wall of the home may result in leakage at the wall. A typical example is the roofs that are on either side of a front entry, which slope towards the wall on either side of the front entry. This type of construction is less than ideal, but is often accepted by the local building authorities. It is usually not practical to modify the slope of the roof. Therefore, it is recommended that these areas be routinely monitored for potential water damage. (Evaluation Recommended)

Issue: Gap(s) were noted at the roof flashing

Explanation: If there are large gaps at the flashings/penetrations the areas with gaps may leak. (Repair Recommended)

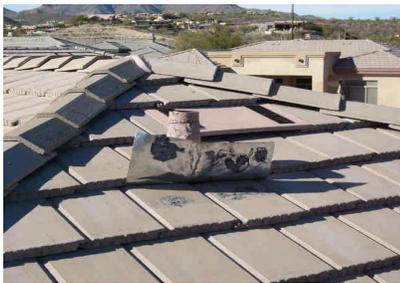
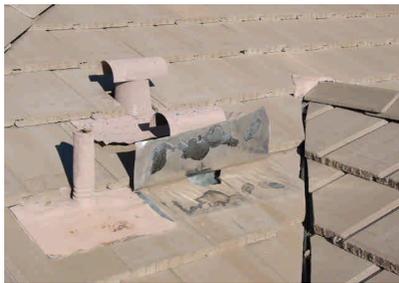
Issue: Loose flashing was noted at roof penetrations

Location: On the roof

Explanation: If roof flashing is loose, it may be lifted by the wind (usually during a rain storm) and may result in a gap or roof opening that moisture can enter. (Repair Recommended)

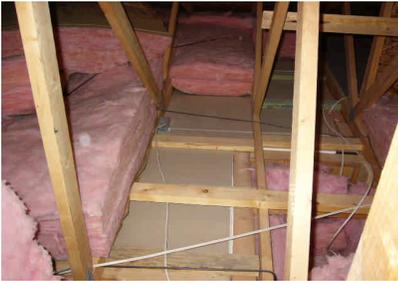
Issue: Missing insulation was noted on the ceiling (Some insulation has been displaced)

Explanation: Insulation should be installed between any heated/cooled area and any area that is not heated/cooled. Areas in the attic above spaces that are not heated/cooled, such as garages, patios and front porches, do not require insulation. (Repair Recommended)

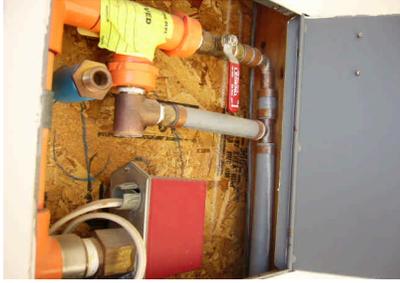
Issue: Polybutylene tubing noted at some portions of the fire protection piping

Explanation: In some installations, water piping utilizing plastic polybutylene may be more prone to leakage than other types of plumbing materials. If this is a concern for you, further evaluation is recommended before closing to determine if there is any other polybutylene plumbing in the house and if repairs are required. (Evaluation Recommended)

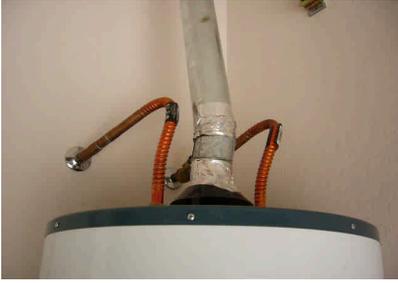
Location: At the water heater

Explanation: A gas flue that is not properly secured can become loose; resulting in the exhaust fumes entering the house. Most building standards require that three mechanical fasteners be used at each gas flue connection, (the fasteners should be evenly spaced around the flue) and where the gas flue connects to the water heater draft hood. (Safety Issue)

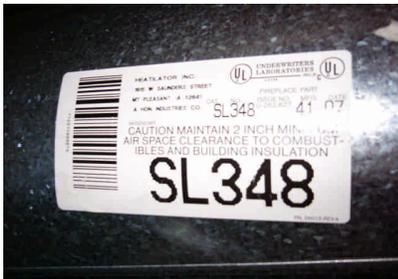
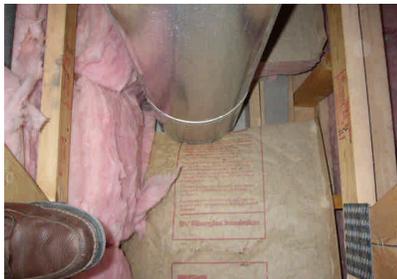
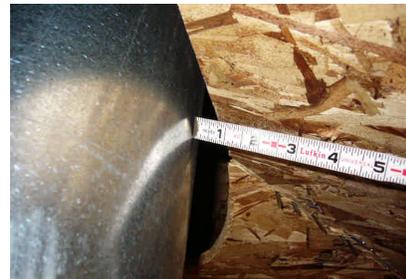
Issue: The fireplace flue or chimney was too close to combustibles (The left photo shows the label indicating that at least 2 inches of clearance should be maintained between the flue and combustible materials.)

Explanation: Fireplace flues must not be too close to combustible materials such as wood, insulation, wiring, etc. or a fire may result. Insufficient clearances should be corrected. (Safety Issue)

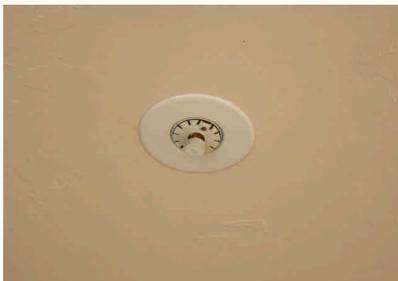
Location: Throughout the house

Explanation: Some Omega brand sprinkler heads, manufactured by Central Sprinkler Co., are subject to a safety recall by the U. S. Consumer Product Safety Commission. For more information, contact the Consumer Product Safety Commission at 800.638.2772 or www.cpsc.gov. (Evaluation Recommended)
